SMART & Multifunctional Tubacoat Technology For CAPEX,OPEX and CO2 Reduction in Refining and Petrochemical And Other Applications

Sanjay Lodha Global Business Director- Tubacoat Tubacex, Spain

> BIOMASS POWER OCTOBER 11-12,2023 STOCKHOLM, SWEDEN

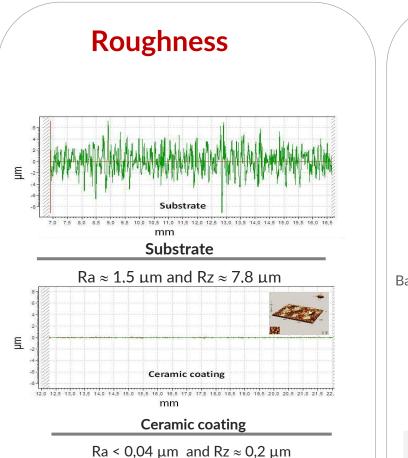
Continuous **coating layer Thickness control** based on suspension parameters & rheological properties

Substrate			cras 100
· · · · · · · · · · · · · · · ·	. 0		
Coating (140-160µm)	· · · · · · · · · · · ·	0.2

Typical coating thickness range: 100-150 μ m

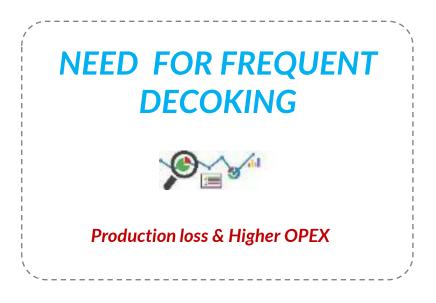
↓ Effective area & ↑ Pressure drop

- Mechanical Pigging: requires shutdown Average pigging cost: 1.6 million USD
- Online Spalling: requires throughput reduction Average spalling cost: 0.6 million USD
- *Average profit of 20,000 BPD Delayed Coker unit

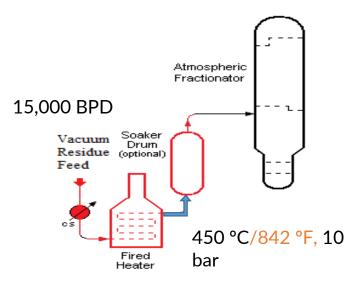
TUBACOAT TRIAL

ID coated tubes, bends and flanges installed at the furnace outlet line to prove anti-fouling properties.

Dimensions: OD 4", Sch. 80 - 317L SS

TRIAL RESULTS (after 12 months)

- Very thin coke layer not detected by Radiographic test - 75% reduction in coke deposition.
- Coke was much easier to remove 3 times lower water pressure than before was enough to remove all the coke.
- **Decoking services** may use softer pigs and cleaning will be less frequent

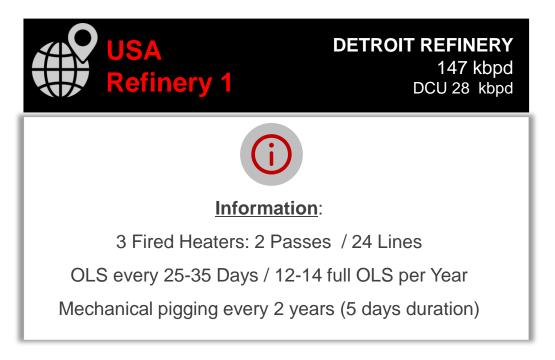
ID Coated DCU Fired Heater Tubes Radiant Coil

• Grade: A213 **T9 Low Cr.**

Delivered: Sept'22

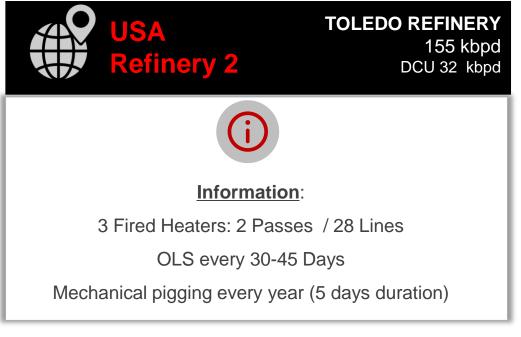
• Grade: A213 347H SS

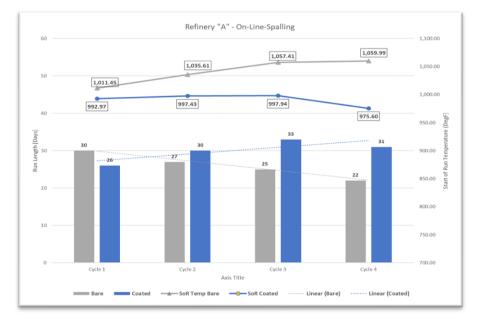
OLS Performance – Bare Tubes

- Run Length (RL) reduction 2-3 days per cycle
- Temperature increase at Start of Run (SoR)

OLS Performance – Coated Tubes

- After OLS, temperatures going back to SoR Temperature (as clean condition)
- RL Cycle improvement, operating longer period of time

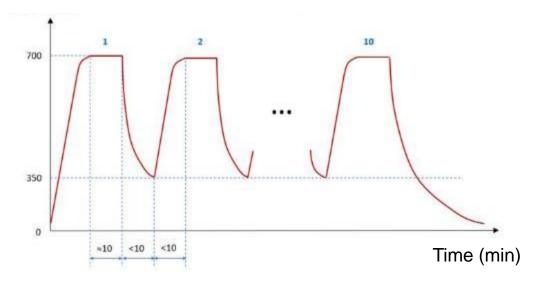
Thermal shock resistance

Temperature

- Excellent coating performance after spalling operations no damage
- Coating has **same expansion coefficient** as base material
- Spalling more effective with coated tubes

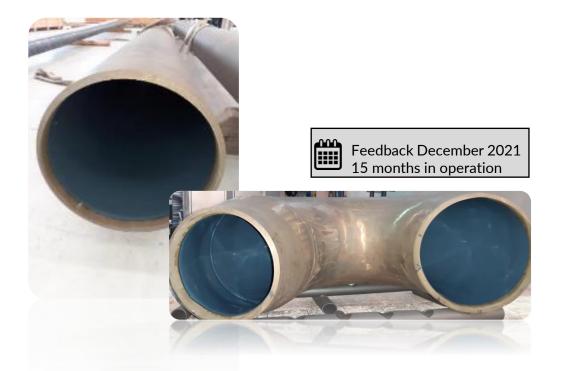
"The ceramic coating can protect the tube ID surface from deposition and, more specifically, prevent coke formation.

The ID examined surfaces do not appear to have appreciable amounts of coke"

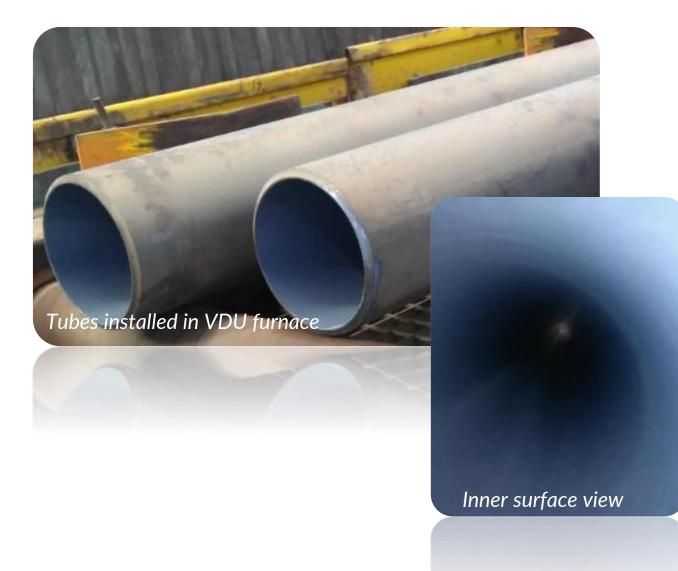
2) VDU unit (Europe)

Tubacoat Solution

- Tubacoat inner coated tubes ٠
- Base material: 317 SS @ ٠ Dimensions: OD 5", Sch. 40

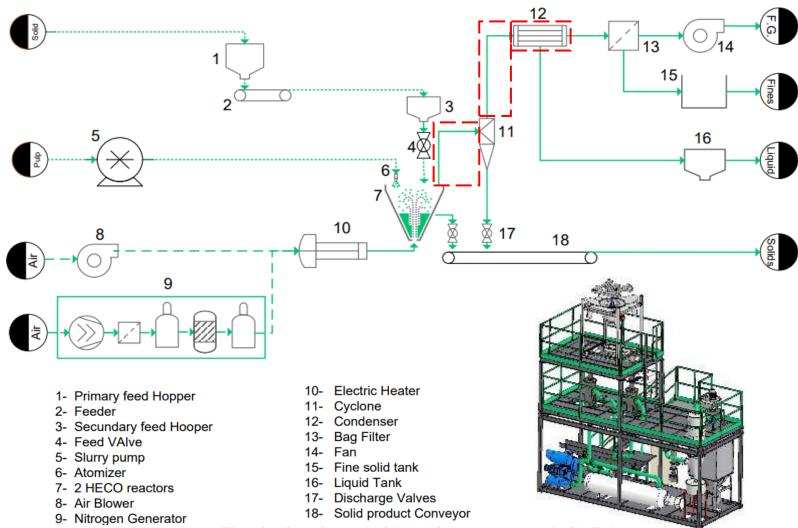
SBS Pilot Plant Diagram

The pipelines framed with red lines were coated with Tubacoat.

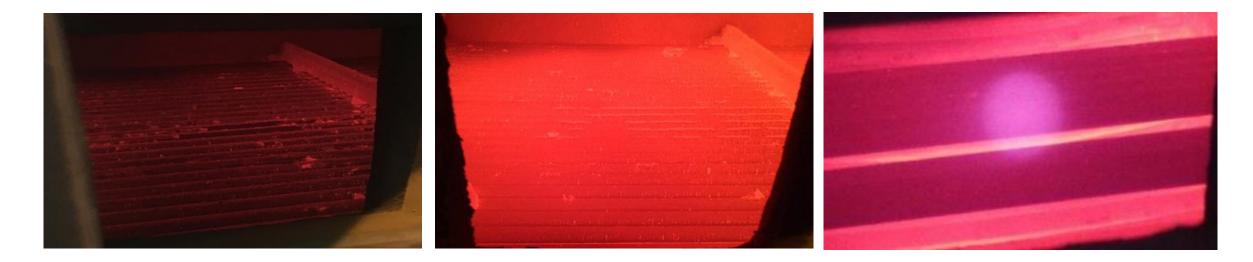
Real pictures of coated tubes in coke calciner recuperator after 15 **months** running in full operation

This refinery received 3 times cycle length, savings of US \$2 million/yr.
